BAM Bouw en Techniek BV
 project: **Dakconstructie AFAS Stadion** drawing size: **A0**
 title: **Dakvlak bouwdeel BCD** revision: **3**
 order: **Gordingen U9 t/m U12** drawing number: **194022-500**
 S-UO-255

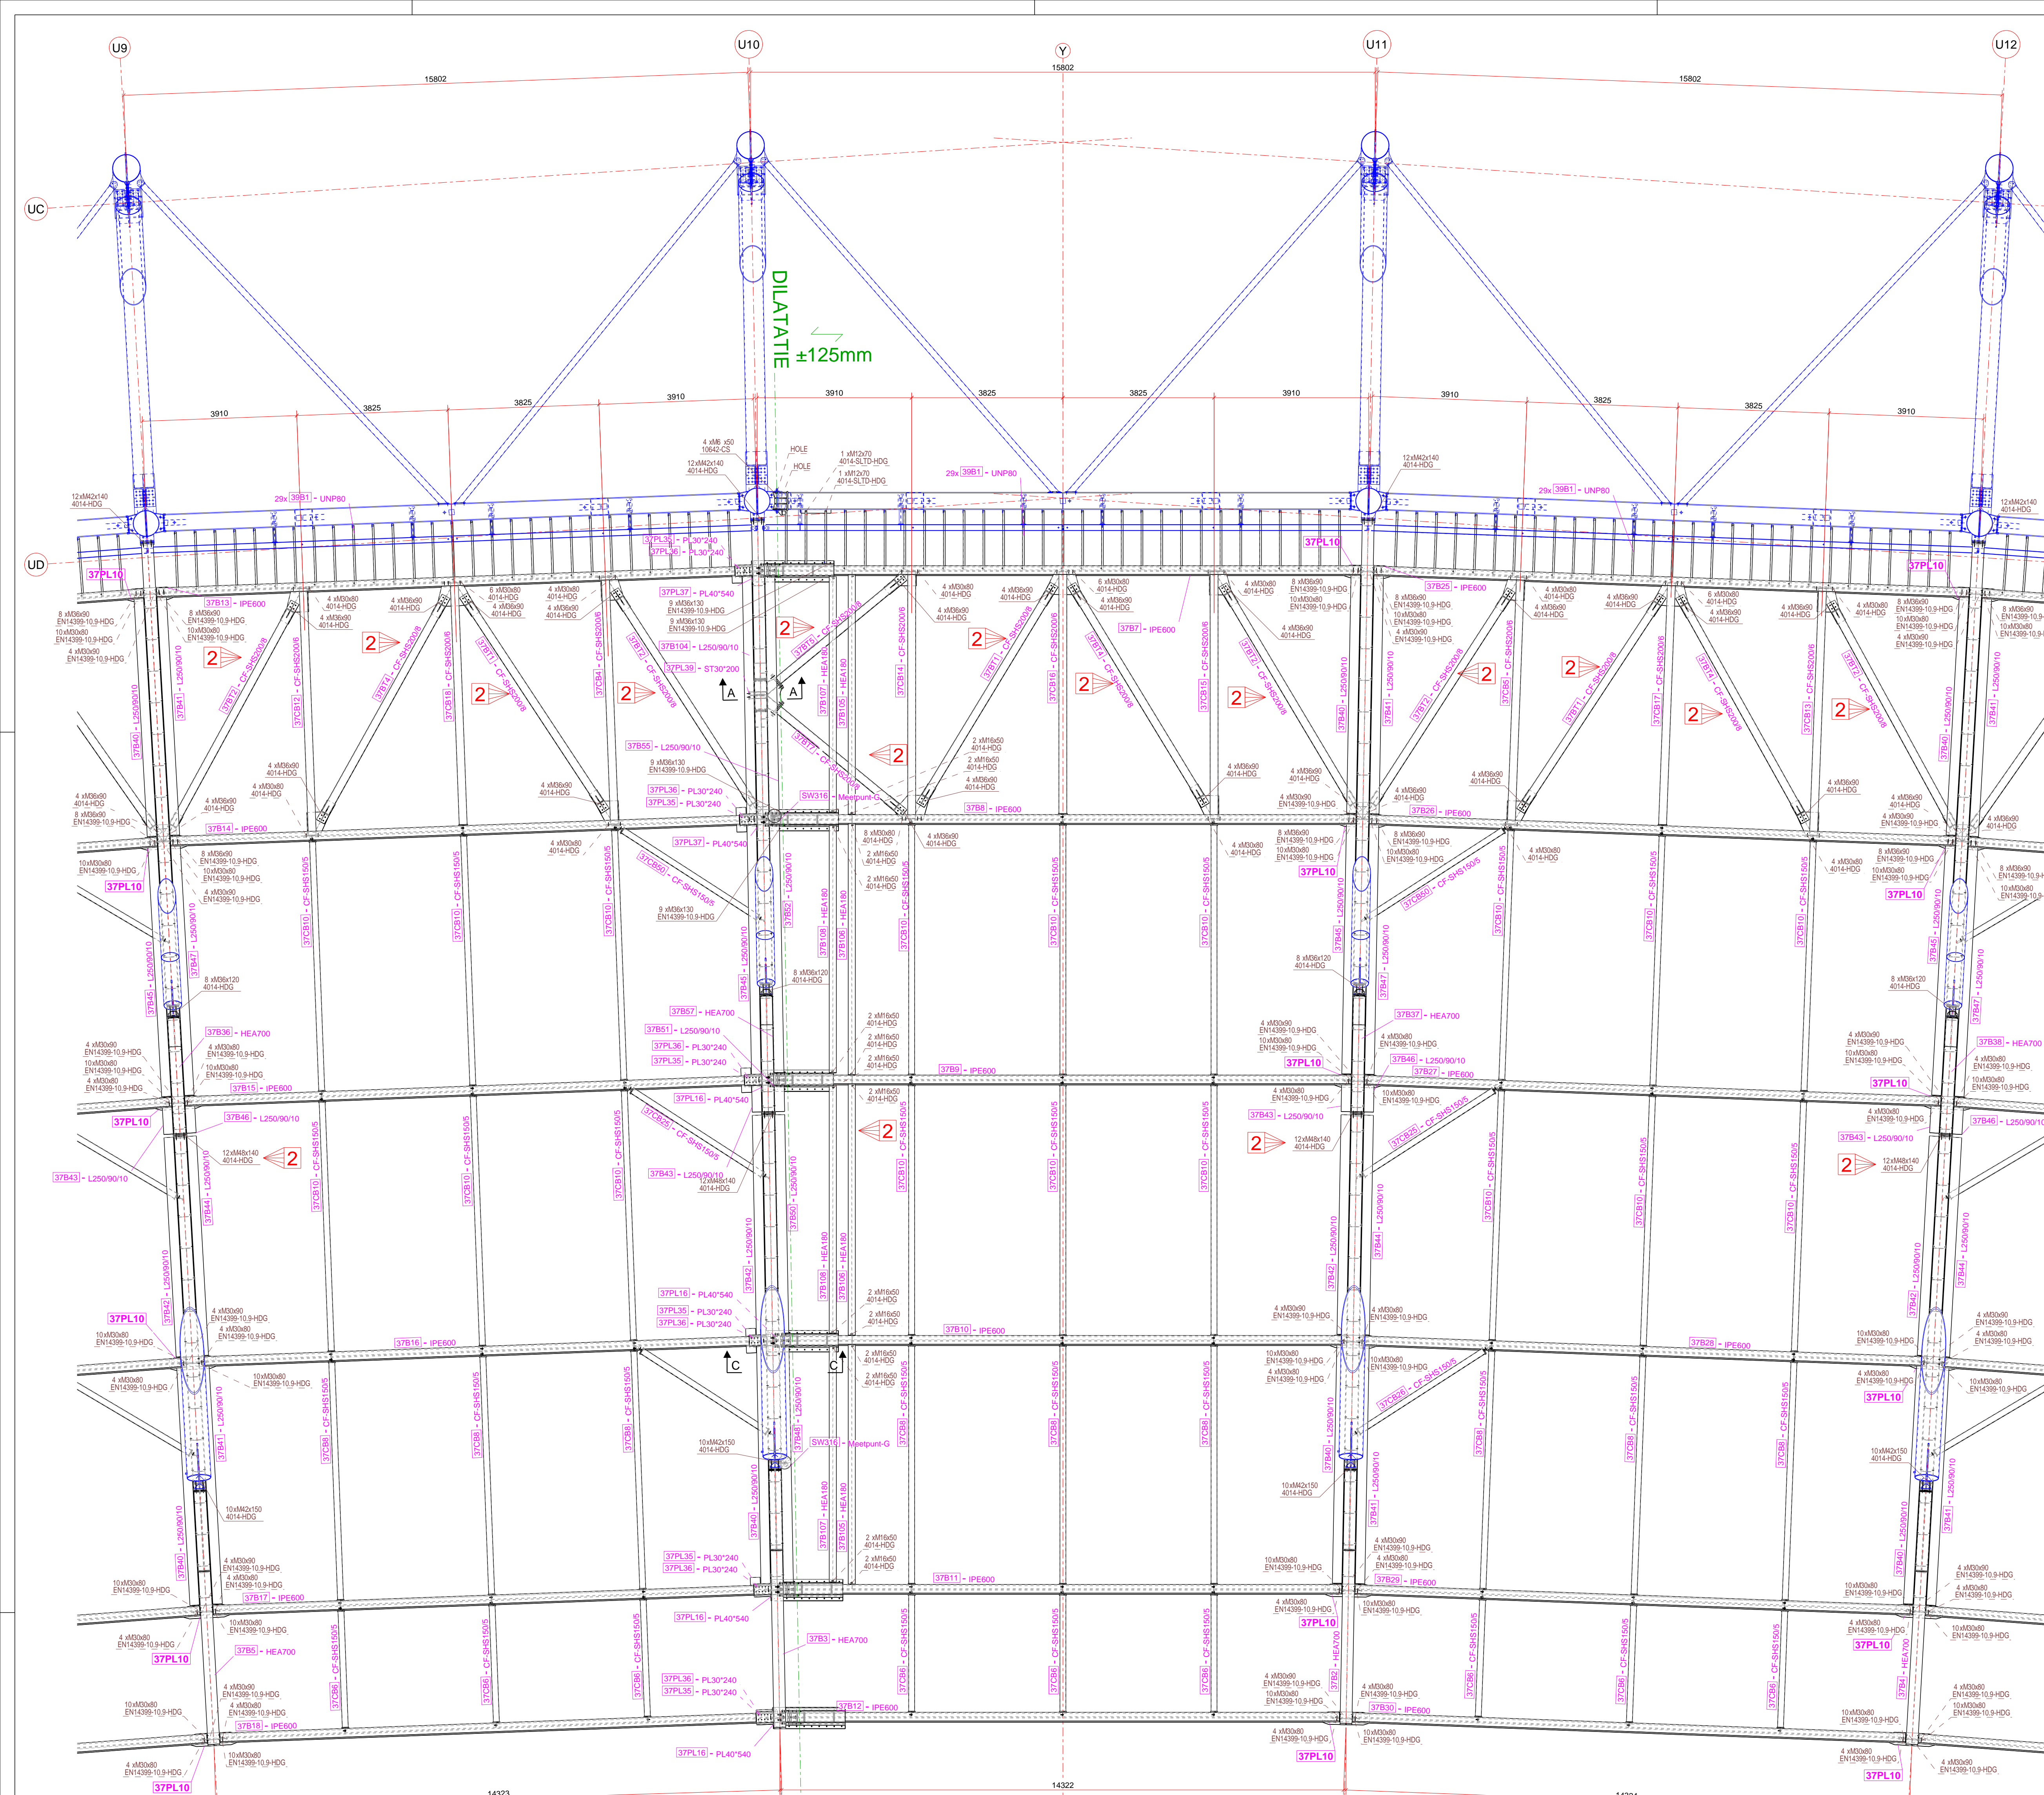
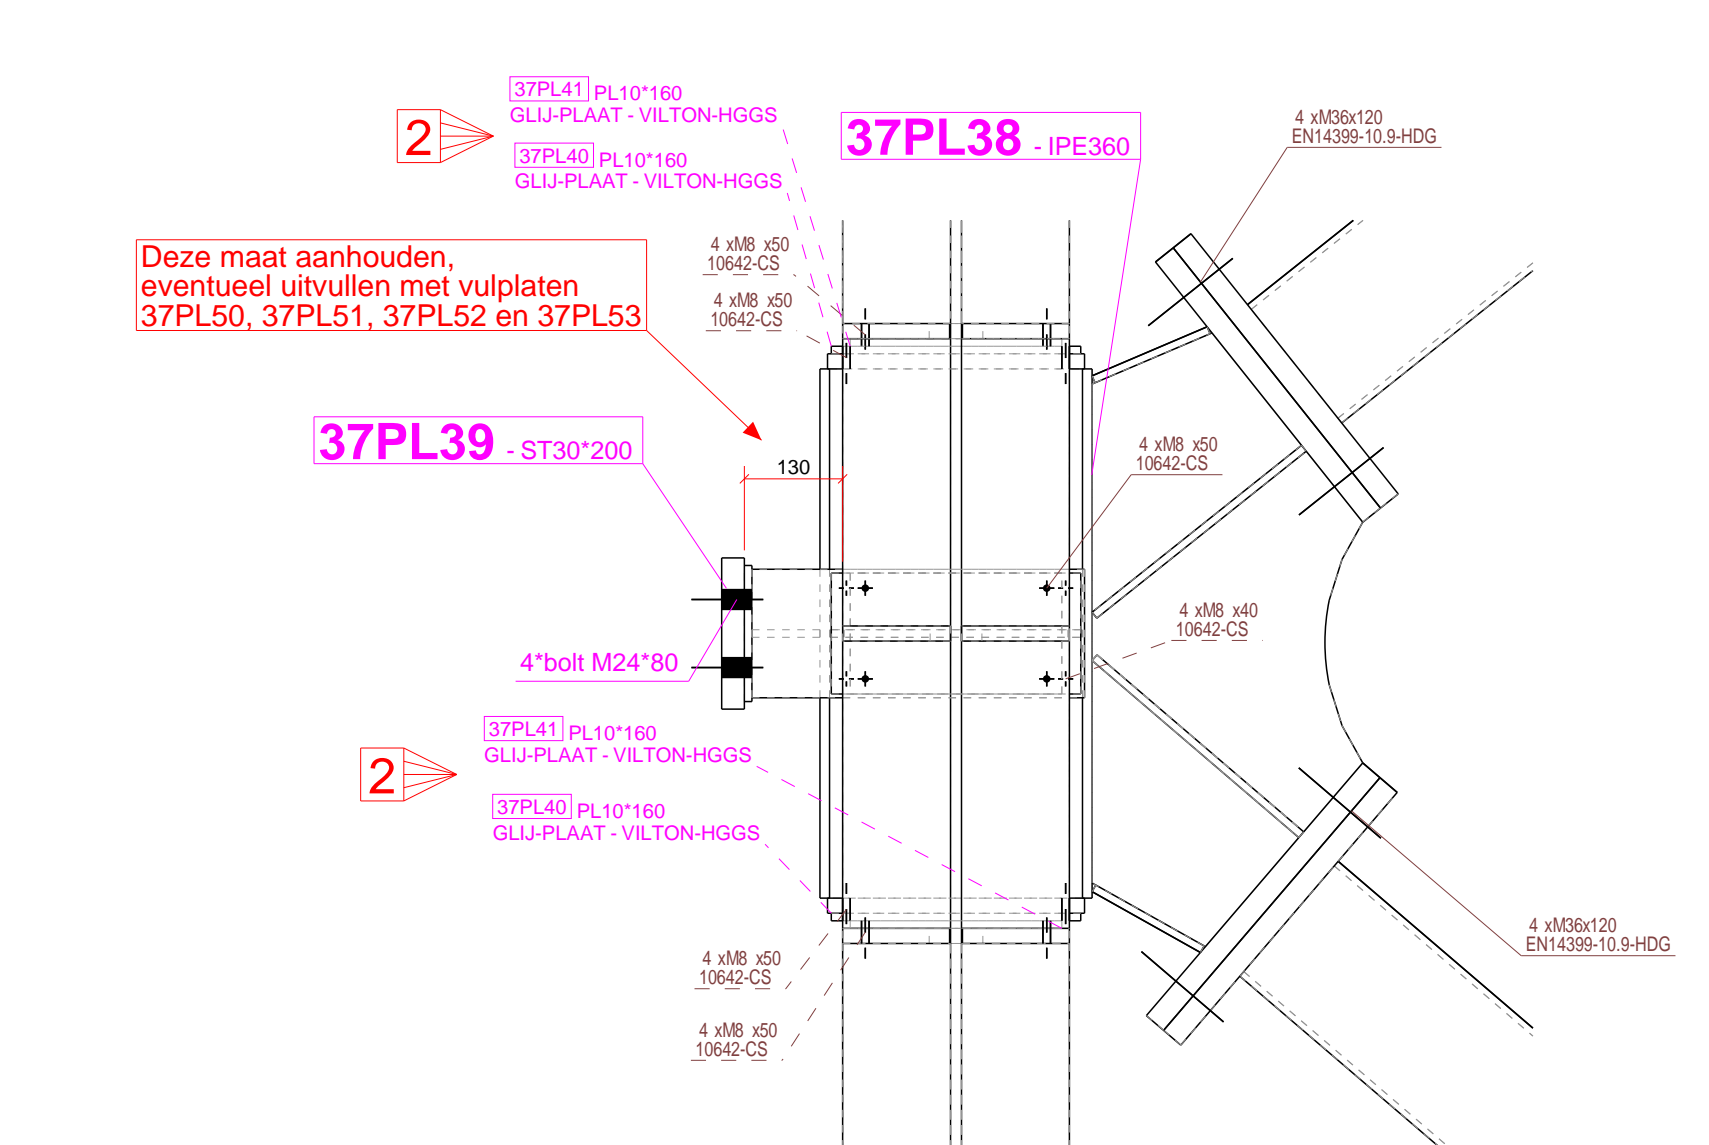
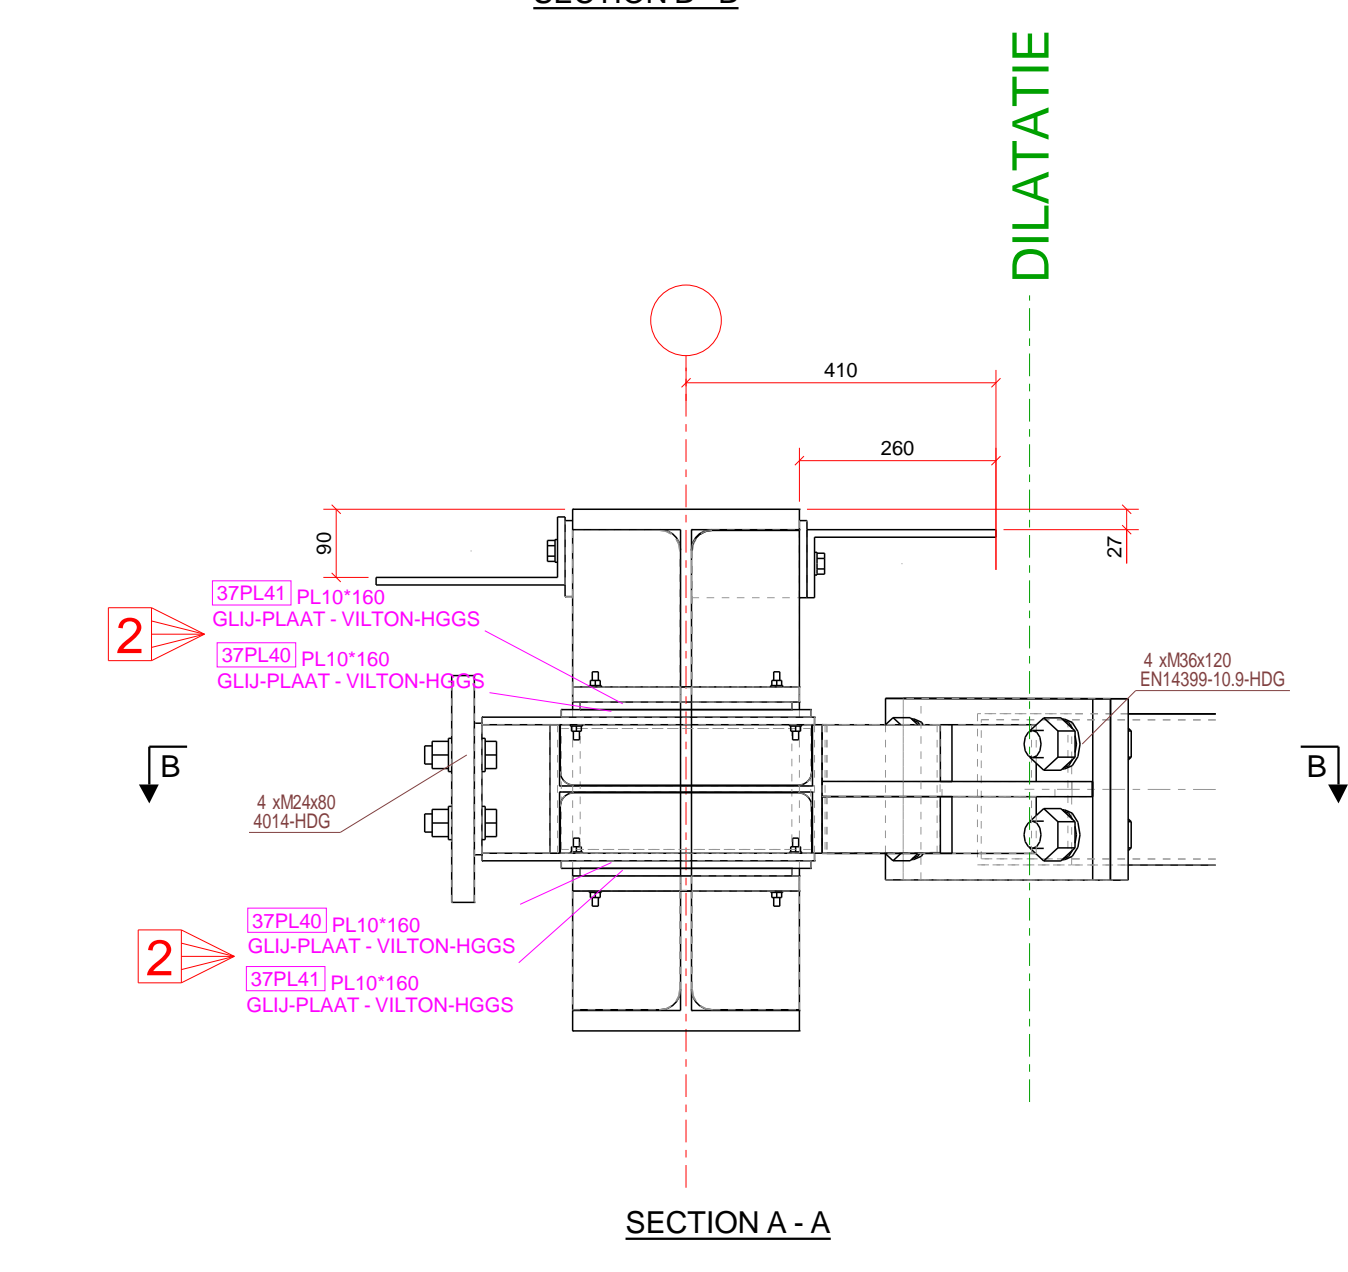
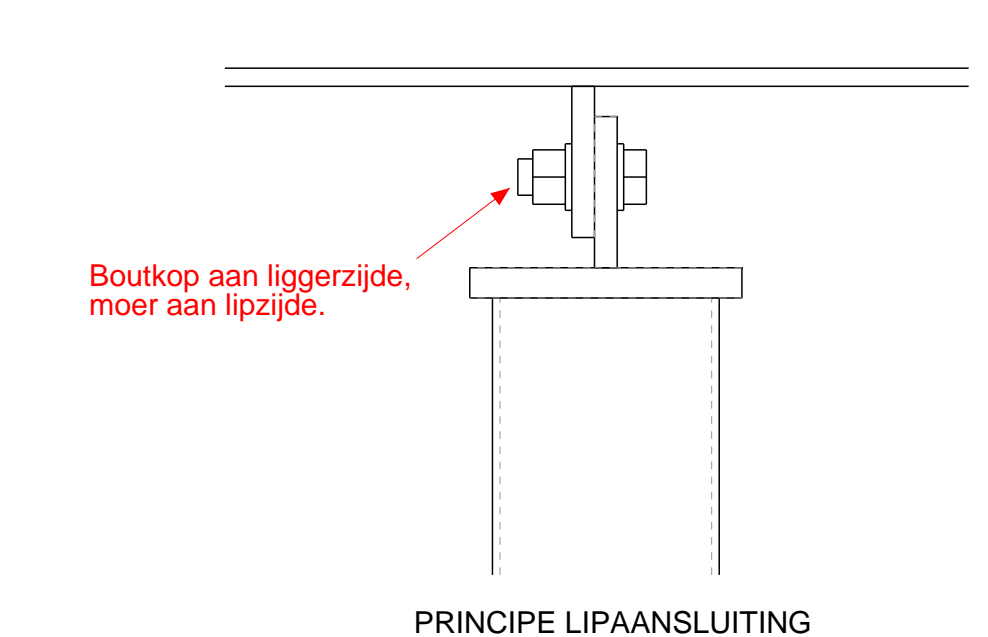
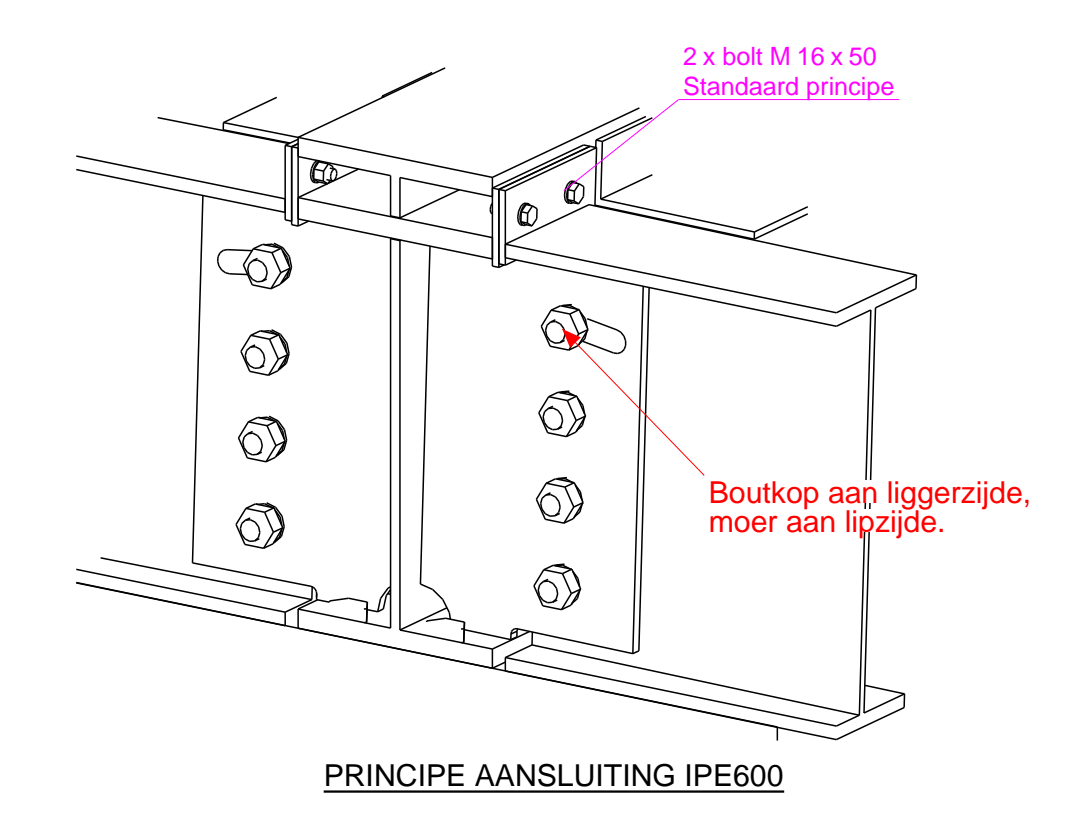
"Bouten M24x70 tav
"Bij lipaansluitingen boutkop aan liggerzijde,
meer aan lipzijde. Zie hiervoor principe diagram"
